**CONTINUING ELIGIBILITY INSPECTION (CEI) REPORT**  
**FOR FLOOD CONTROL WORKS**  
Honolulu Engineer District  
CEPOH-EC-T

1. Project Name: Pa'auau FCP
2. Date of Inspection: October 18, 2005
3. Inspection Personnel:

The project provides for approximately 263 LF of levee, 5 cement rubble masonry walls of 590 feet, 272 feet, 151 feet, 120 feet, and 682 feet. The project was damaged as a result of a flooding event in Jan. 2004 and is currently awaiting repairs under the PL84-99 program. Damages were identified at approximately 25 areas. All deficiencies were brought to the DPW's attention during the inspection.

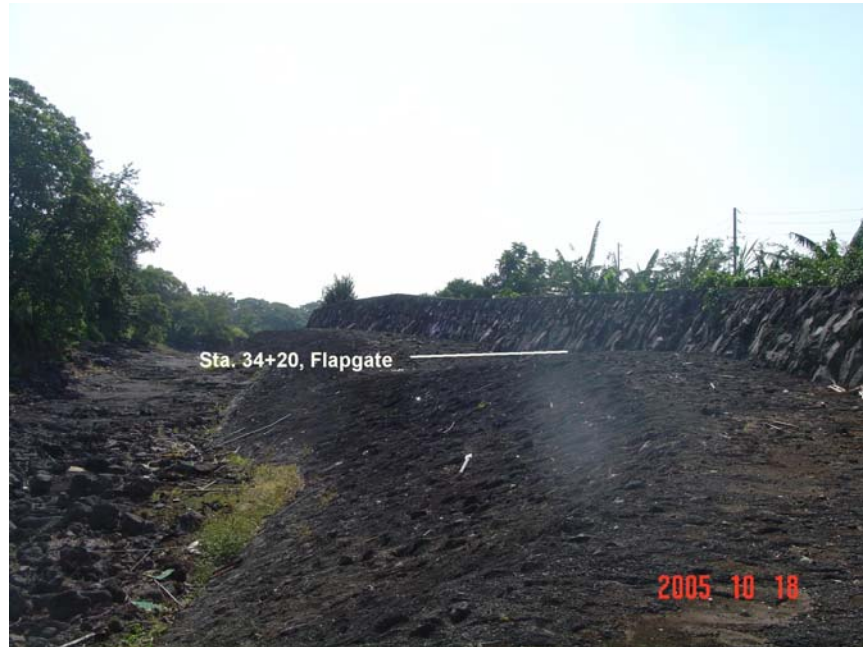
- a. Sta. 34+00 - Sta. 35+00, remove vegetation from the toe of the concrete bolder Slope Lining (CBSL).

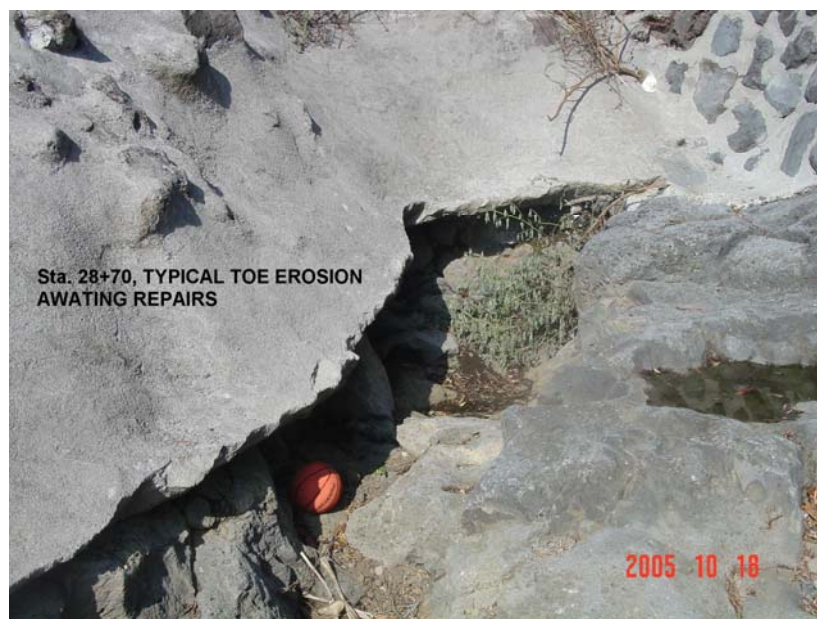
- b. Sta. 28+70, RB, typical of toe erosion awaiting repairs.

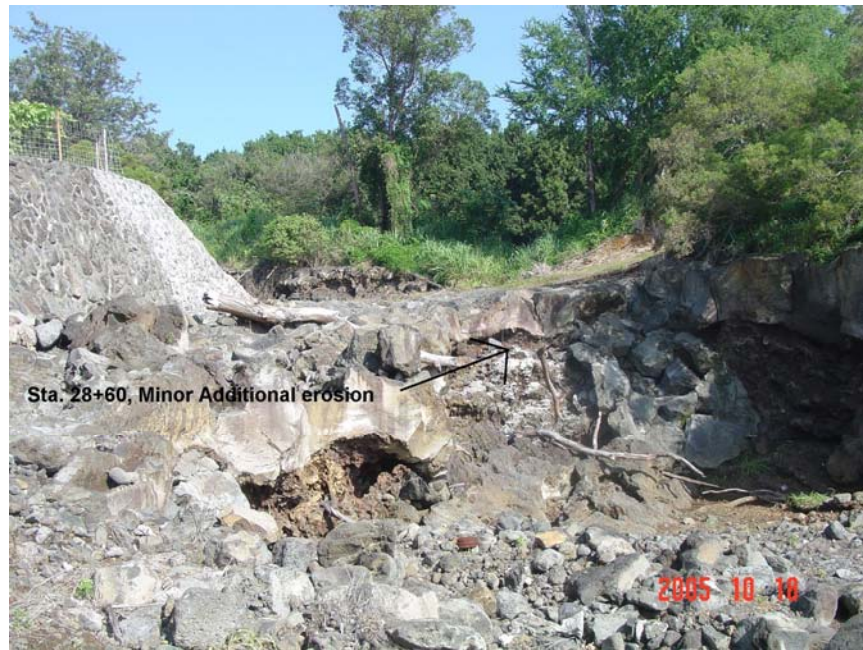
c. Sta. 28+60, Not part of the 2000 Repairs, minor additional erosion noted this inspection.

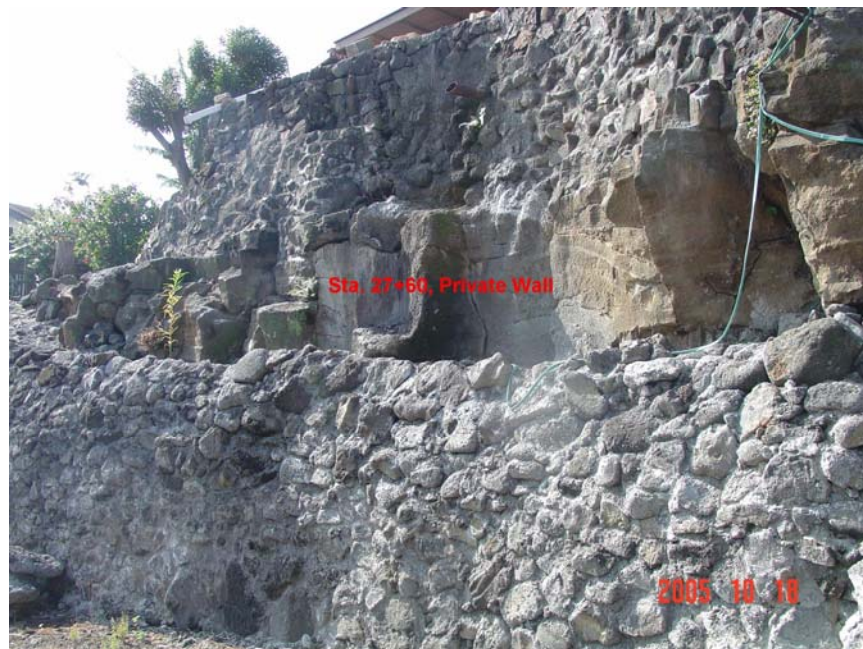
d. Sta. 27+60, private wall constructed, not part of the Federal Project.  
268 LF CRM Wall B:  
Sta. 26+73 - 23+62

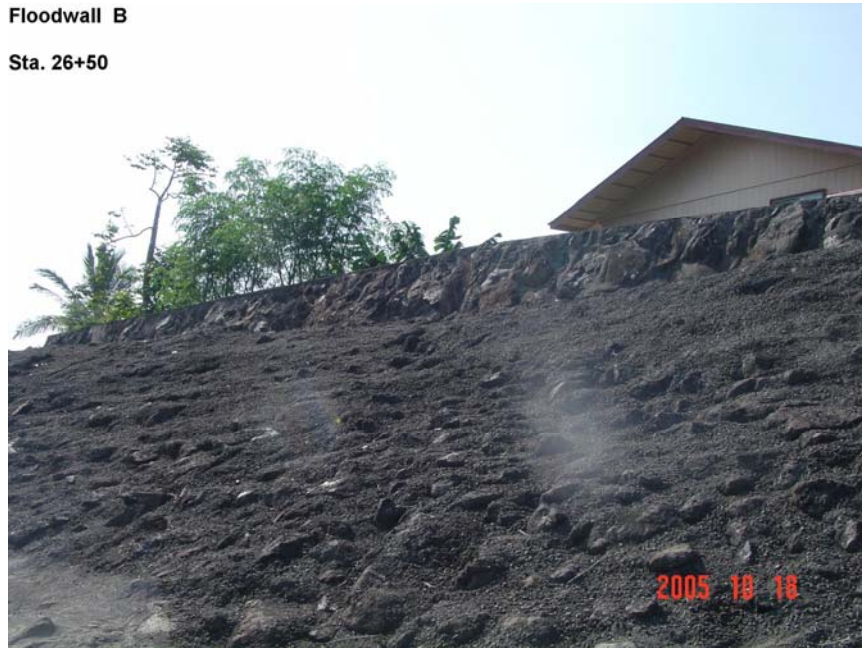
**Sta. 26+50**

- e. Sta. 26+50, RB, Remove vegetation from Floodwall B.

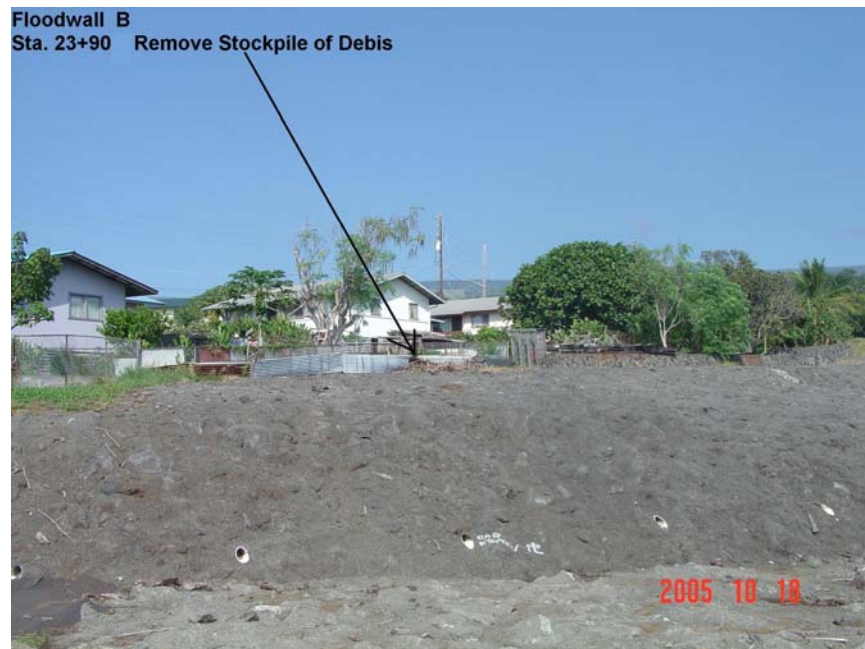
- f. Sta. 23+90, RB, remove stockpile of debris from Floodwall B.  
150 LF CRM Wall C:  
Sta. 21+15 - 19+48

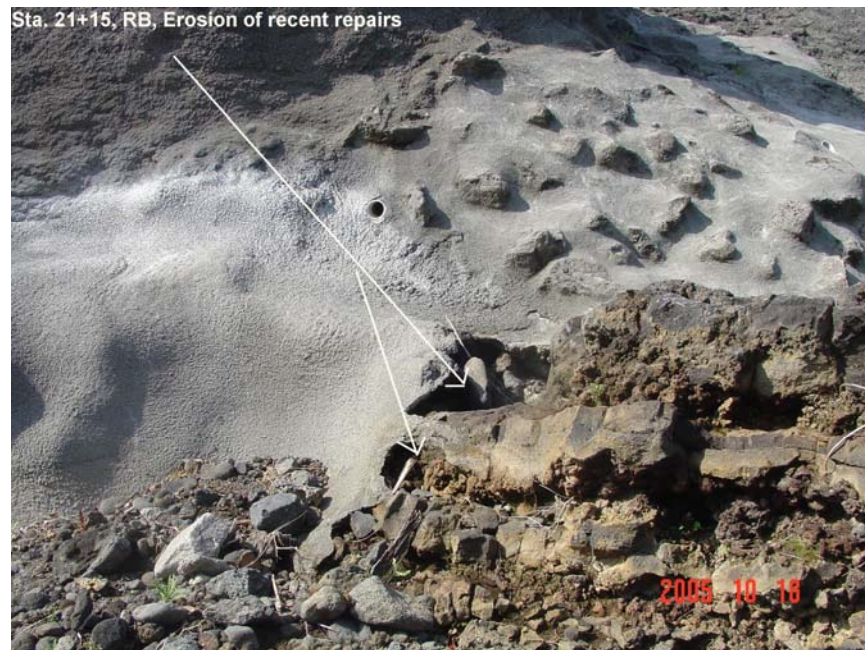
g. Sta. 21+15, RB, toe erosion awaiting repairs.

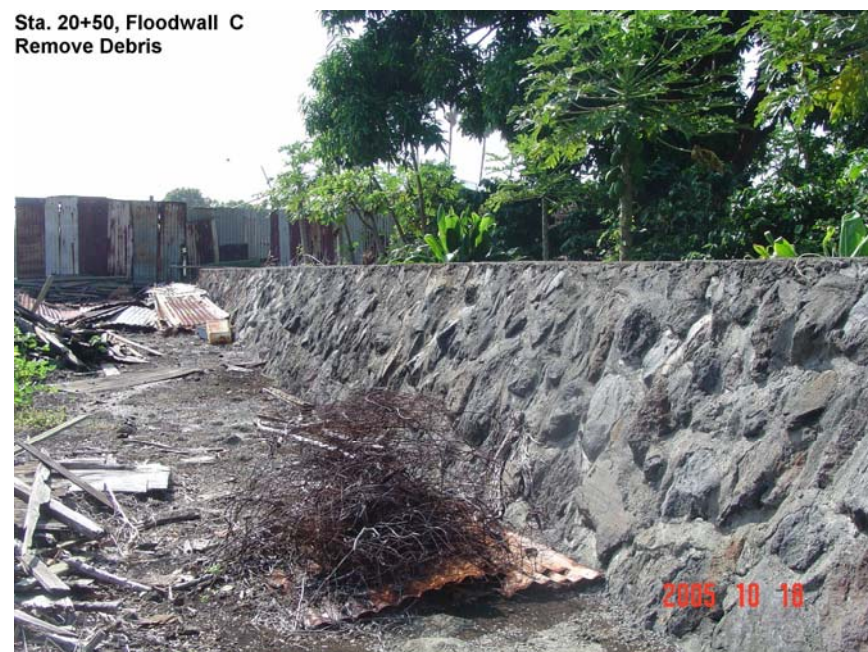
h. Sta. 20+50, RB, Floodwall C, unable to inspect all due to vegetation and stockpile of debris.

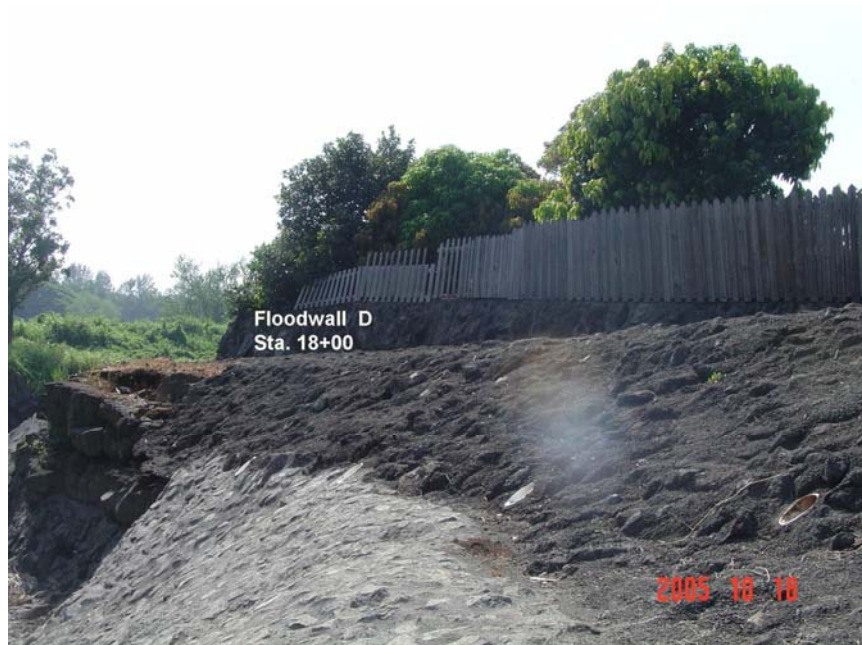
j. Sta. 18+00, RB, recent repairs CBSL between Floodwalls C & D.  
**680 LF CRM Wall E:**

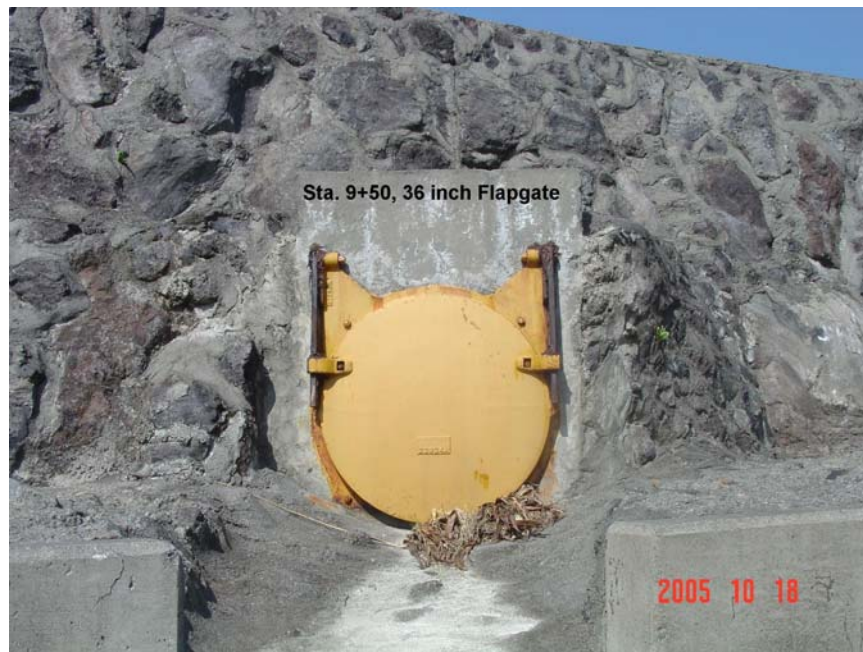
m. Sta. 9+50, Continue to grease flapgate.

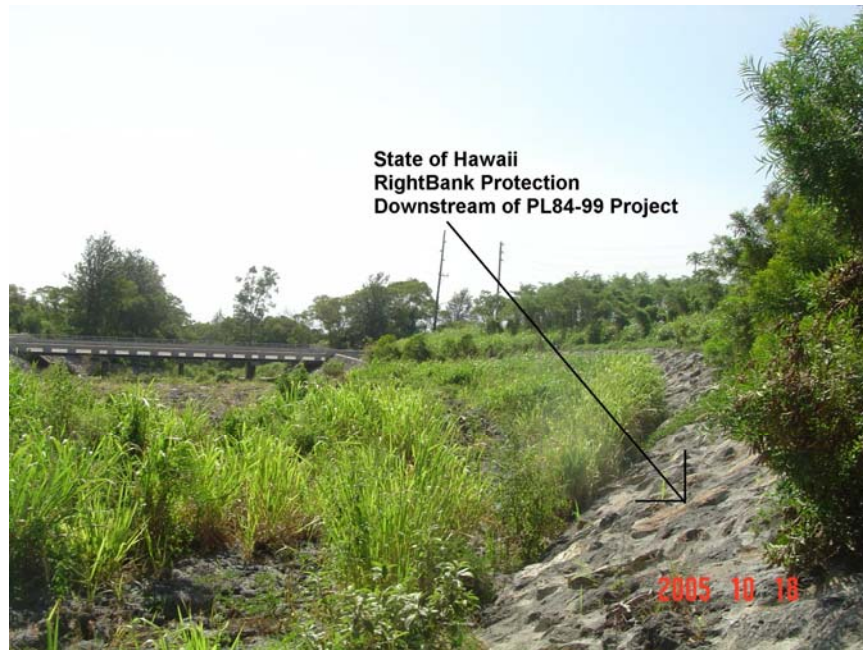
NOTE: The right bank protection below Floodwall E is not part of the Federal Flood Control Project.
